REPORT (DRAFT)

Cornwall Beach & Dune Management Plans – Marazion

Prepared for

Cornwall Council

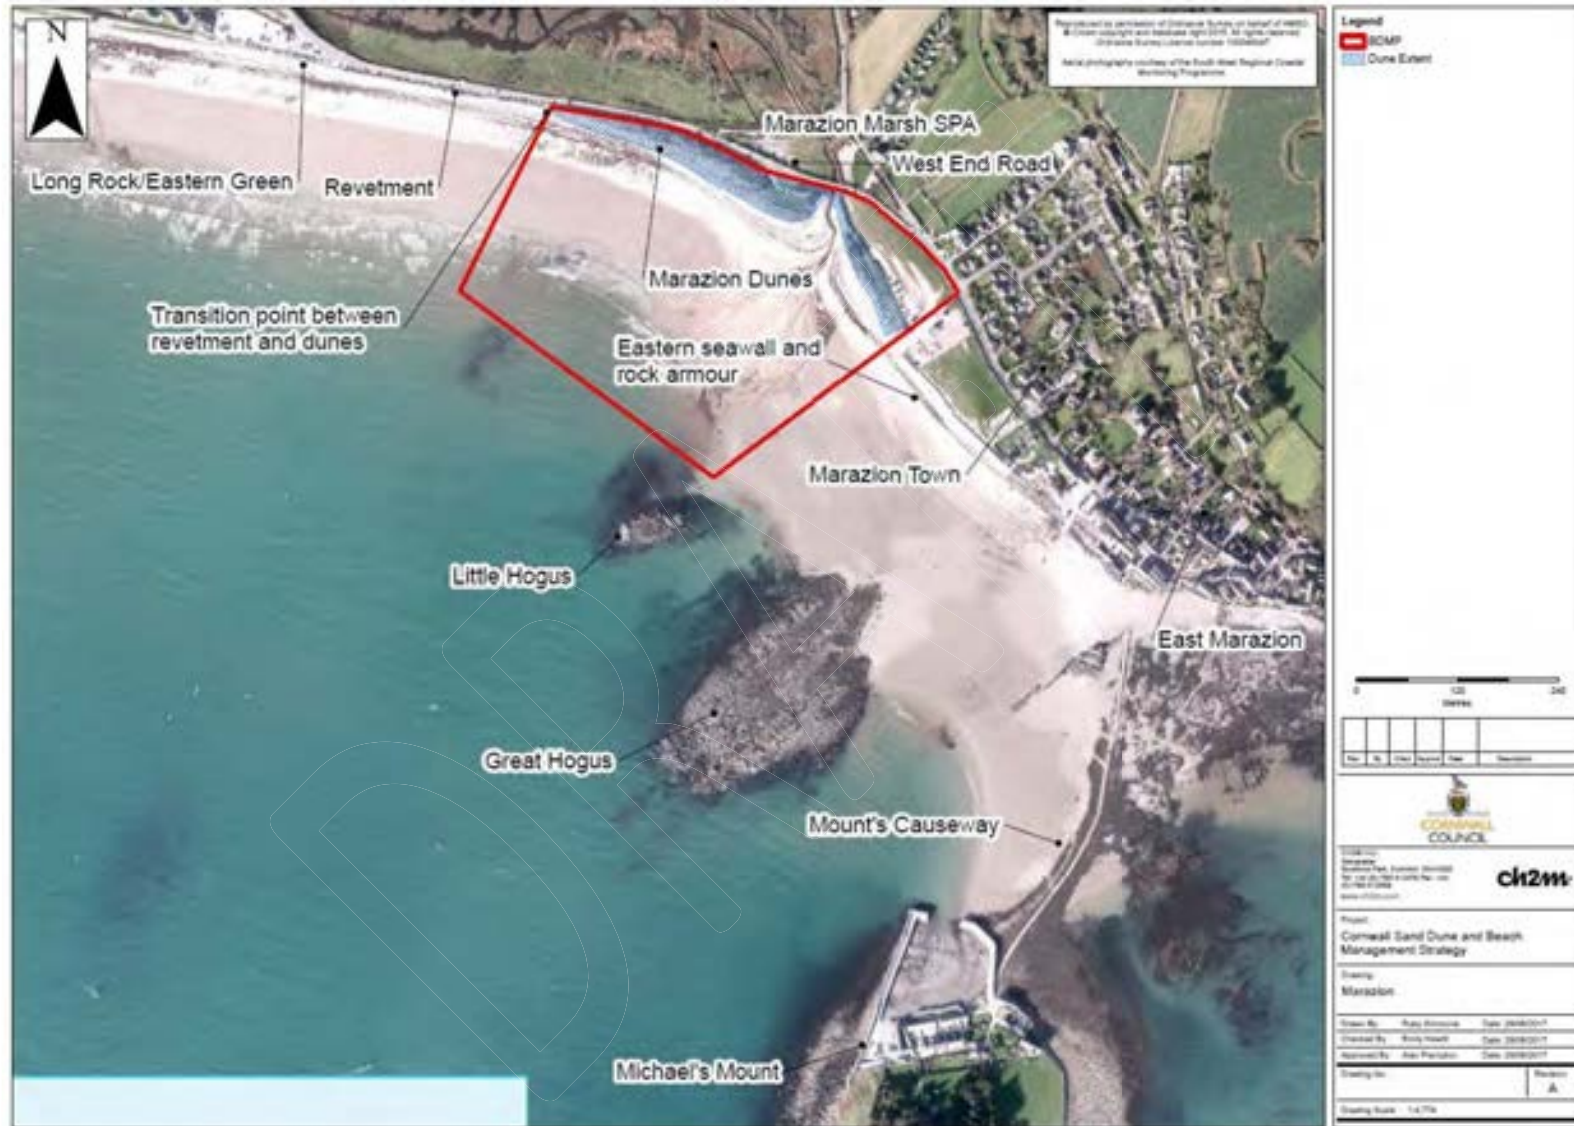
Figure 2.1 Map showing the Marazion BDMP location and extent (red outline).

Marazion is located on the south-west coast of Cornwall. The site is situated within the wider embayment of Mount's Bay which includes Penzance and Newlyn to the west and the Lizard Peninsula and Porthleven to the east (refer to Figure 2.1).

Marazion is located on the south-west coast of Cornwall. The site is situated within the wider embayment of Mount's Bay which includes Penzance and Newlyn to the west and the Lizard Peninsula and Porthleven to the east (refer also to Figure 2.1 above). The whole of Mount's Bay coastline is formed of Devonian rocks including mudstones, volcanic lava and tuffs (Royal Haskoning, 2015) with rocky outcrops, typical for this part of the UK coastline along Devon and Cornwall. Marazion is bounded by The Long Rock in the west and St Michael's Mount in the east. Between the two outcrops, is a wide, shallow plan shape bay with sandy beach backed by sand dunes.

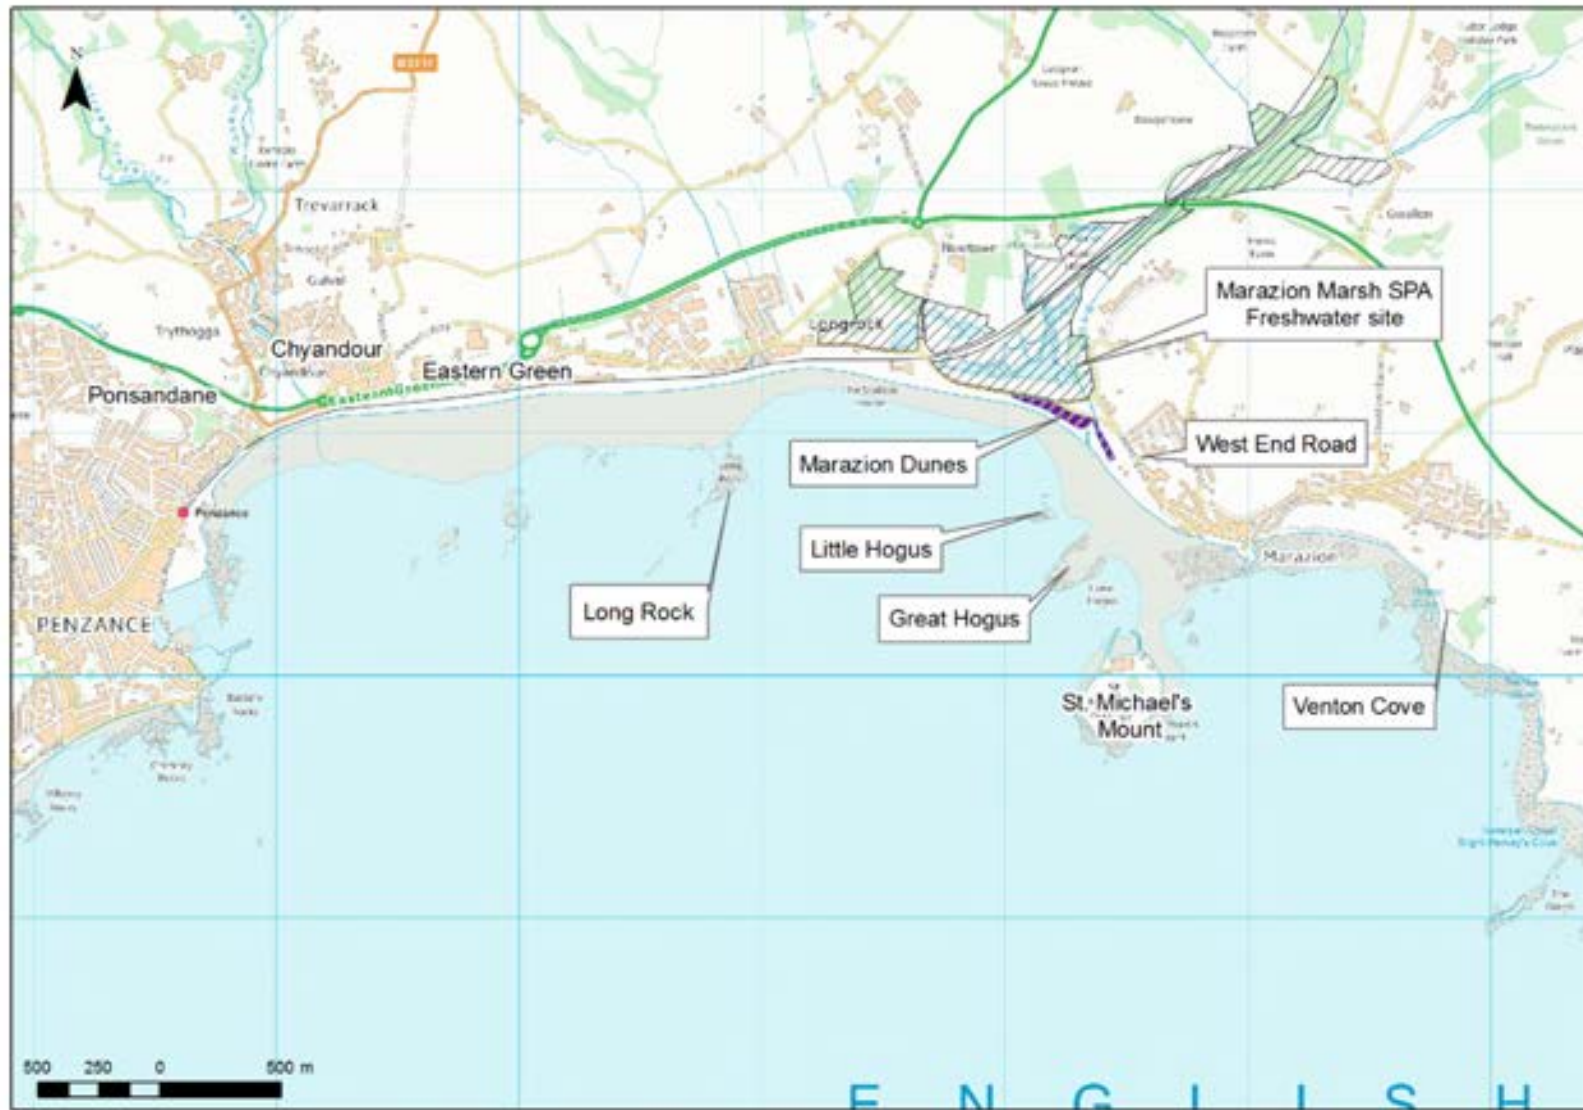
Figure 2.2 Map showing location of Marazion relative to wider Mounts Bay features.

With reference to Figure 2.2, the principal characteristics of the present beach and dune system within the wider Mounts Bay context are as follows:

St Michael's Mount SSSI, fringes the south west coastal section of on St Michael's Mount (see Figure 2.2 above). The SSSI is designated for its geological cliff and foreshore exposures which is described by the following citation:

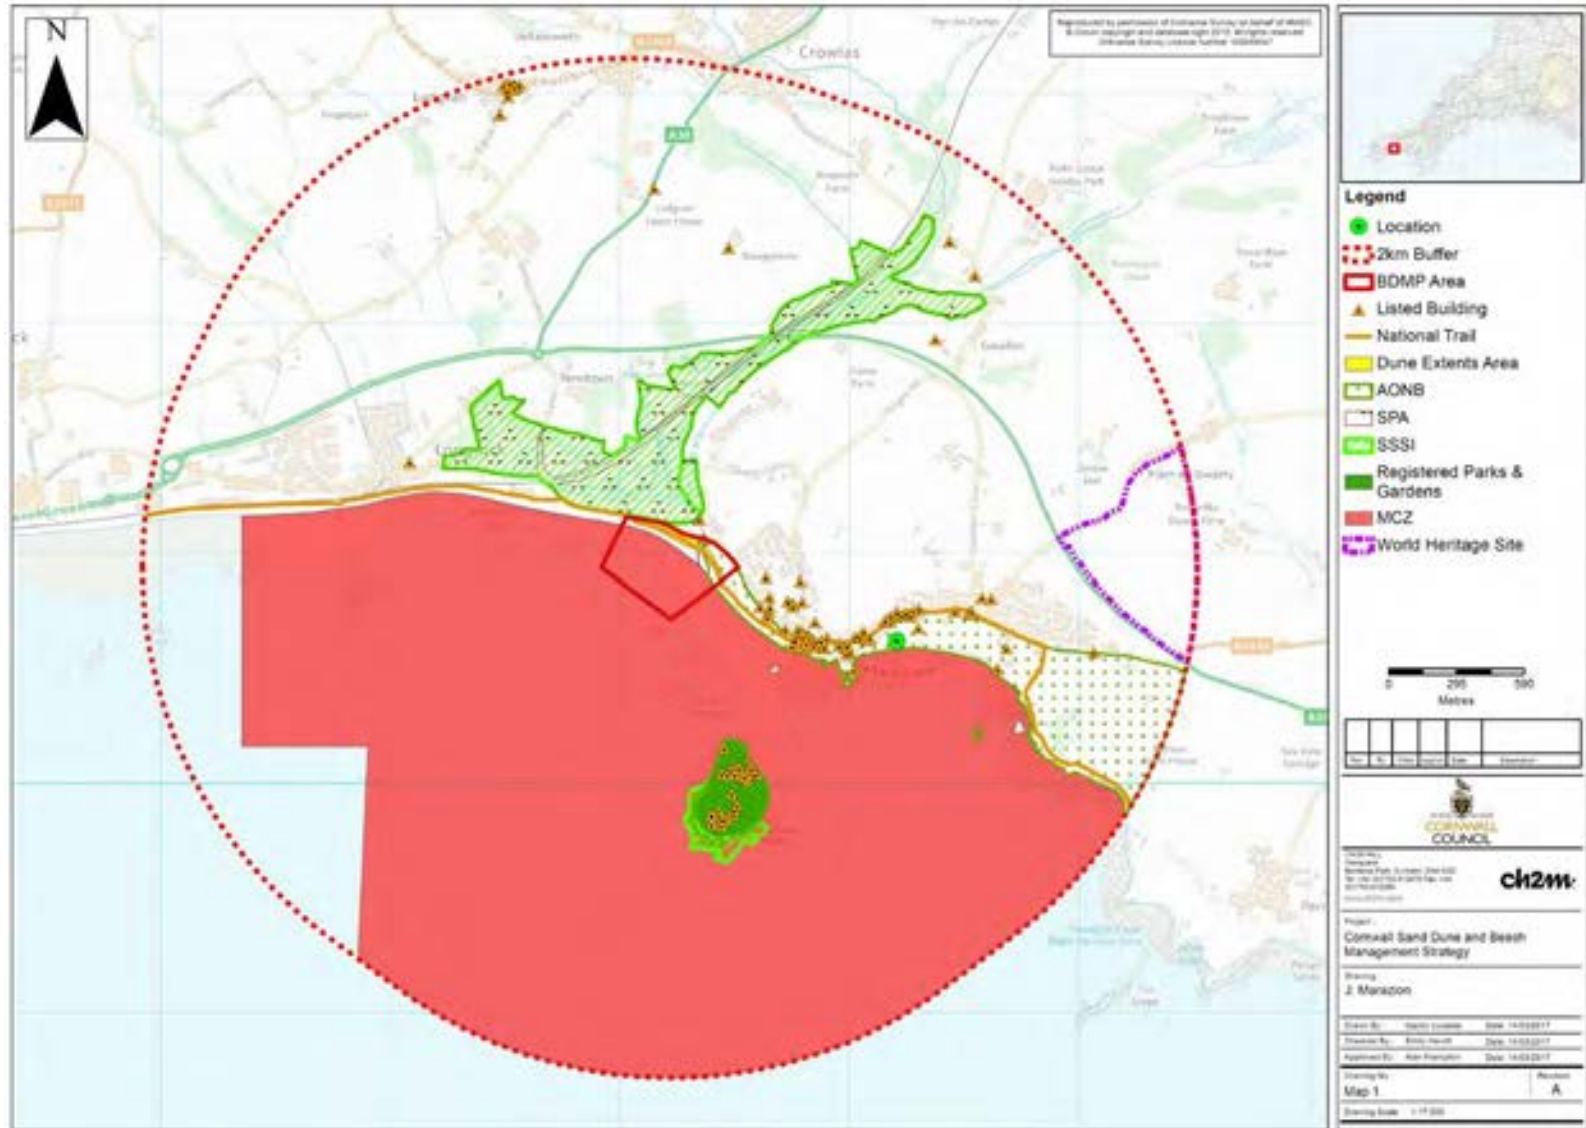
Figure 2.3 Environmental designation features in the vicinity of the Marazion BDMP area.

These features are shown on Figure 2.3 and discussed in further detail below.

The importance of high quality landscape, seascape, and visual amenity to the Marazion area is recognised by the following important designations (see Figure 2.3 above) and require consideration when undertaking beach and dune management measures:

The importance of historic and cultural heritage to the Marazion and surrounding area is recognised by the following national designations, which will need to be considered when undertaking taking beach and dune management activities at Marazion (see Figure 2.3 above).

There are a number of listed structures and listed buildings are present in close proximity of the BDMP study area (see Figure 2.3 above), including:

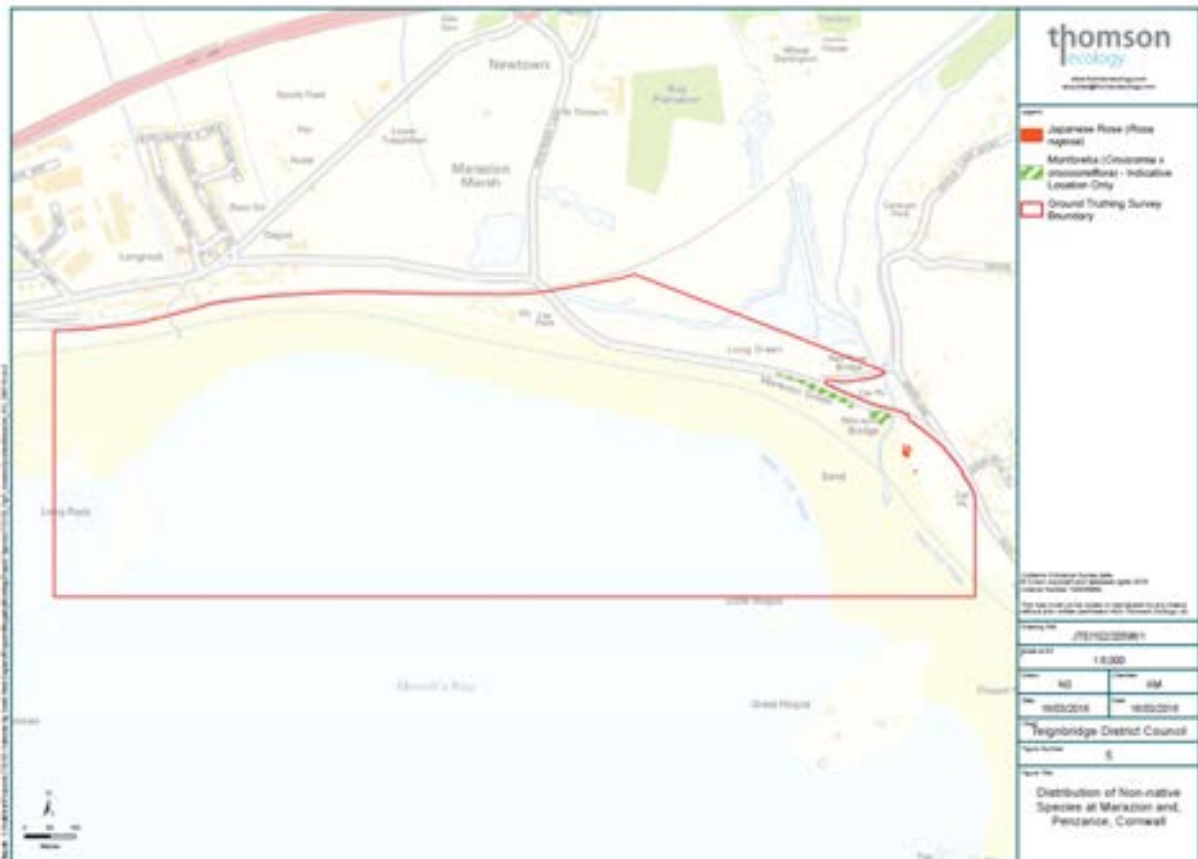
Figure 2.5 Distribution of non-native plant species at Marazion (Thomson Ecology, 2016)

The extent of Japanese rose consists of three small patches with a total area around 300 m² located close to the car park. The extent of montbretia shown is indicative only (Thomson Ecology, 2016). The encroachment of Schedule 9 invasive non-native species Japanese Rose and Montbretia is concerning for the following reasons:

Japanese Rose (*Rosa rugosa*) and Montbretia (*Crocsmia x crocosmiiflora Montbretia*) are invasive non-native plant species listed under Schedule 9 of the Wildlife and Countryside Act (1981) as amended. The Wildlife and Countryside Act (1981) as amended lists invasive non-native species that are likely to have a significant impact on habitats, native species or have economic or social impacts within Schedule 9. These species have been identified within the dune habitat of the Marazion Marsh County Wildlife Site within the BDMP study area (Thomson Ecology, 2016. See Figure 2.5 below).

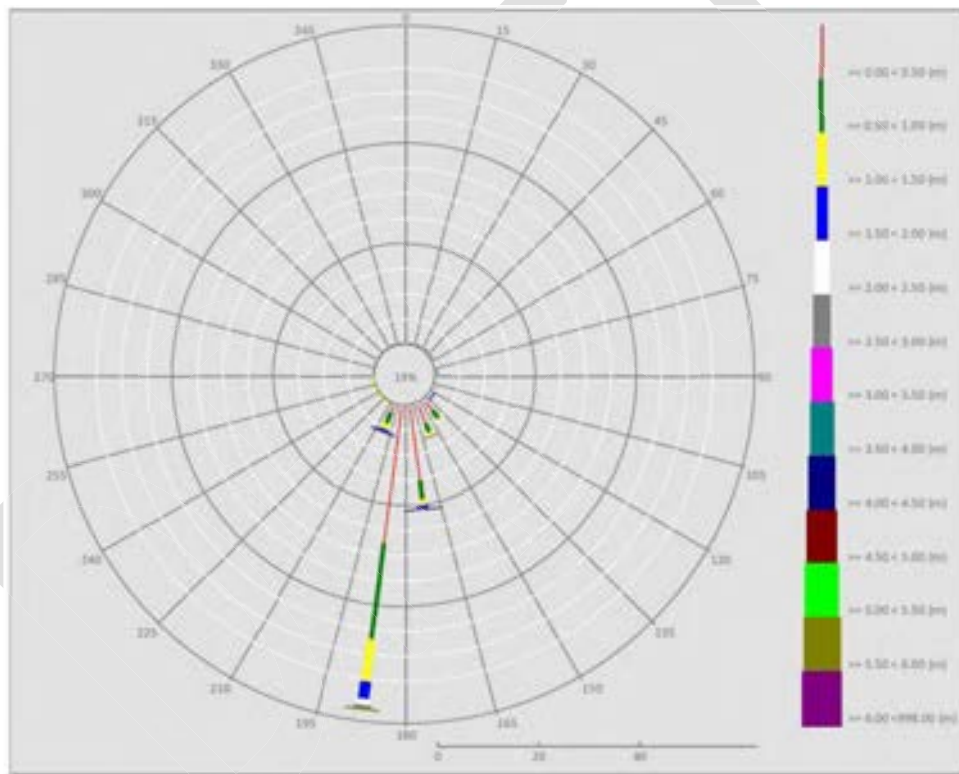
Figure 3.1 Offshore wave height recorded by the Penzance Directional Waverider Buoy between 6th April 2007 and 31st December 2015 (PCO, 2015a).

The Penzance Directional Waverider Buoy, operated as part of the South West Regional Coastal Monitoring Programme (SWRCMP) is the nearest wave buoy to Marazion, and has been reviewed for this study (refer to Figure 3.2 for the wave data point).

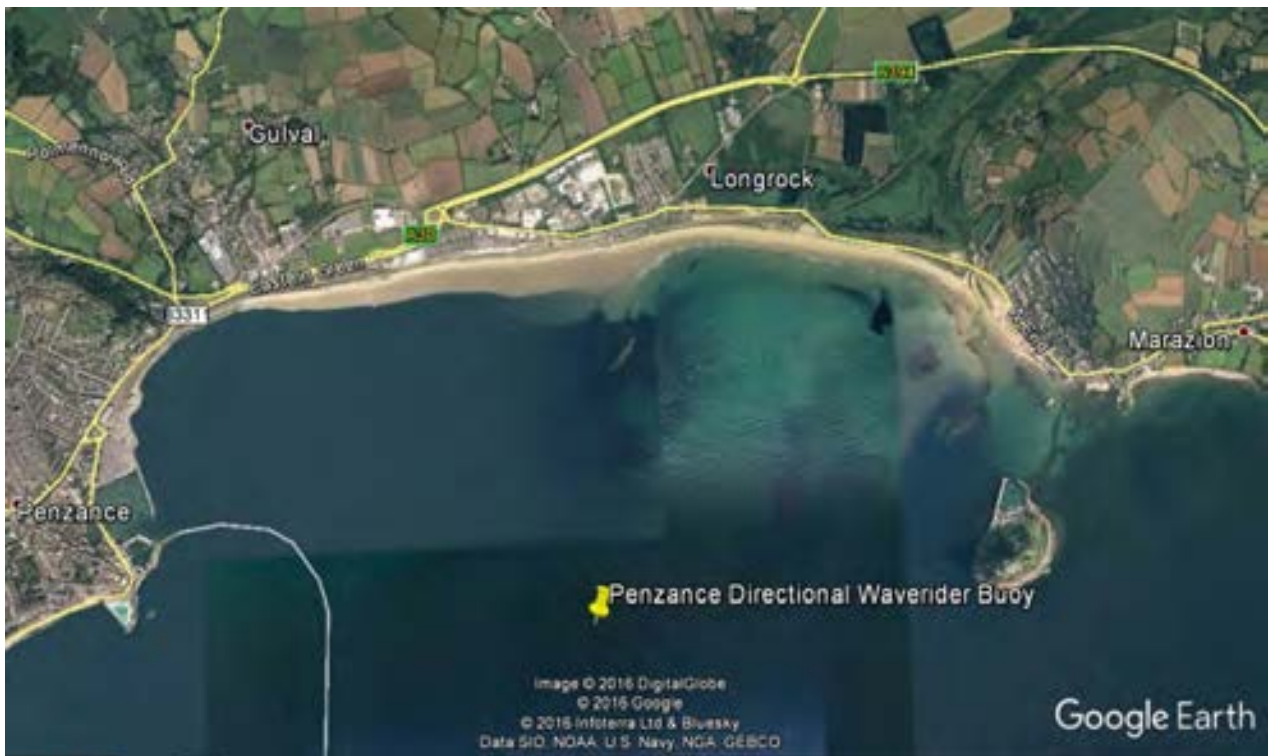
Figure 3.2 Map showing the location of the wave data collection points at Penzance relative to the coastline.

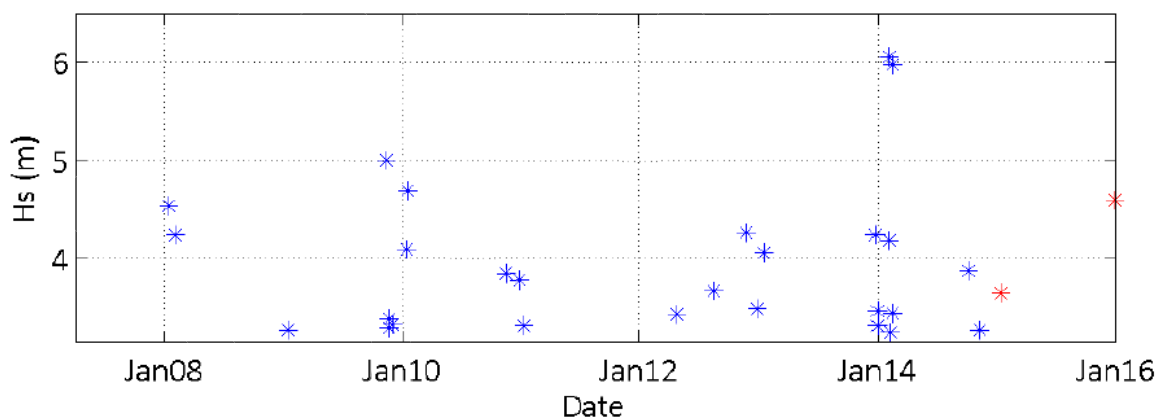
Figure 3.3 Storm calendar for Penzance 2008-2015 (PCO, 2015a)

Figure 3.3 presents the storm events from 2008 to 2015 to understand the frequency and magnitude of events. In addition, more recent data (PCO, 2015a) indicates there were two significant storm events in January 2015 and December 2015. Details of these events are recorded in Figure 3.4 and Table 3.2. It is likely that with sea level rise increased water levels and hence wave energy will lead overall to increased impacts on the shoreline (erosion and overtopping). Figure 3.3 above shows storms (significantly above the $H_s=3.25\text{m}$ threshold) with several storms occurring in Jan 2010 and Jan 2014. There has been only 2 storm events above the threshold in 2015 (see Figure 3.4) but there may have been additional storm events in 2016 which would exceed the threshold.

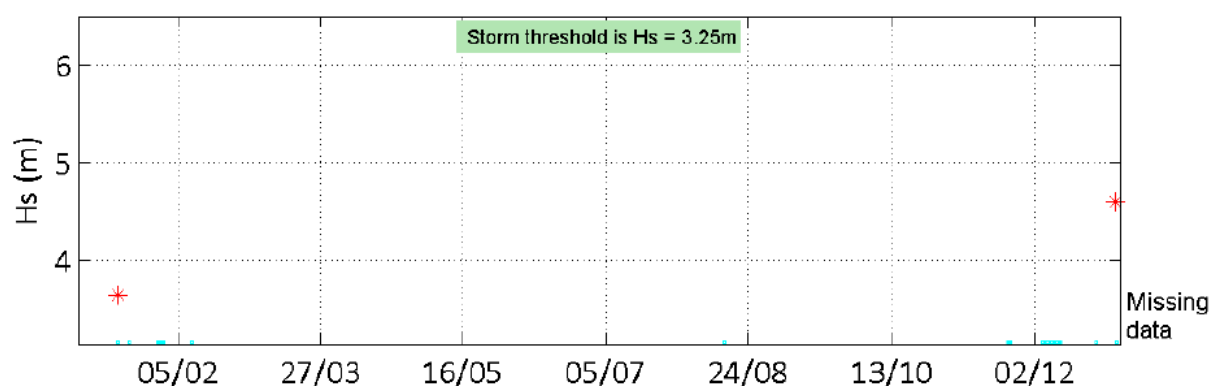
Figure 3.4 Storm calendar for Penzance during 2015 (PCO, 2015a)

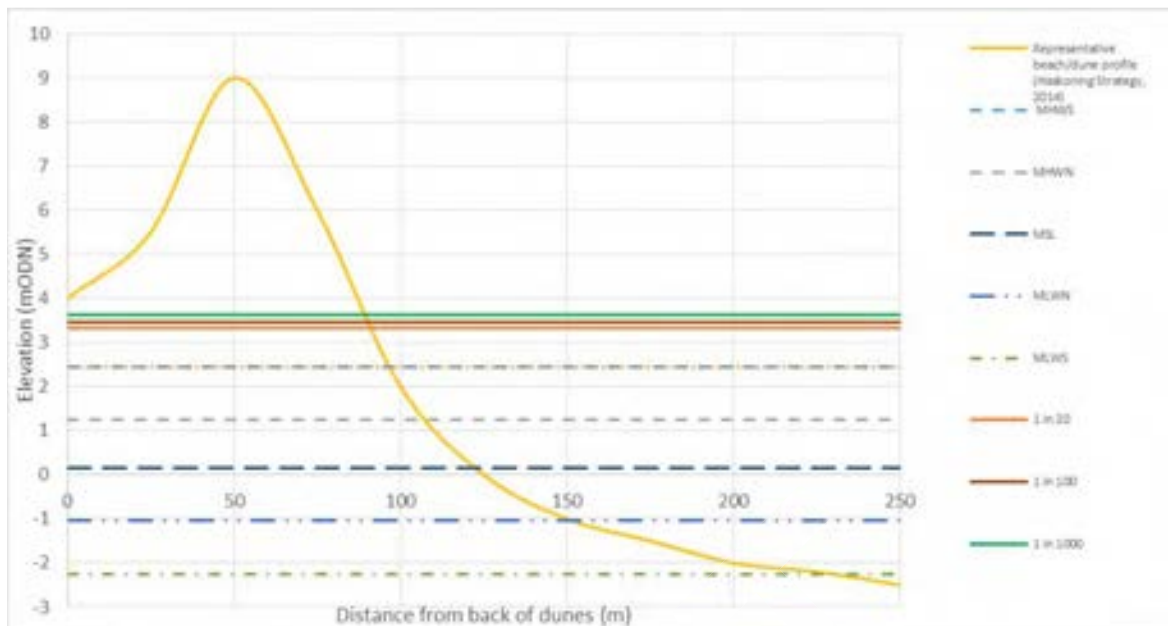
Figure 3.4 Cross section of a typical dune profile. Note the key wetting and dry areas of the beach and dunes under different conditions.

Figure 3.4 presents a cross-section of a typical dune profile (extracted from Royal Haskoning, 2015) against regular and extreme tidal levels. Generally, the toe of the dunes (up to 1mODN) are exposed to regular tidal impacts (i.e. wetted area). It's only under extreme conditions that the dune is impacted (up to 4mODN). However, this excludes potential wave impacts.

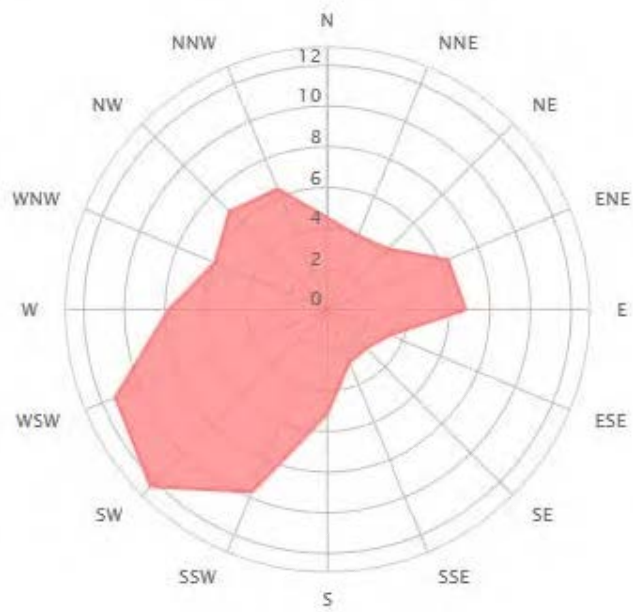
Wind direction distribution in (%)
Year

Figure 3.5 Observations taken between 11/2000 - 03/2017 from Porthleven/Culdrose Airport. Source :windfinder.com.

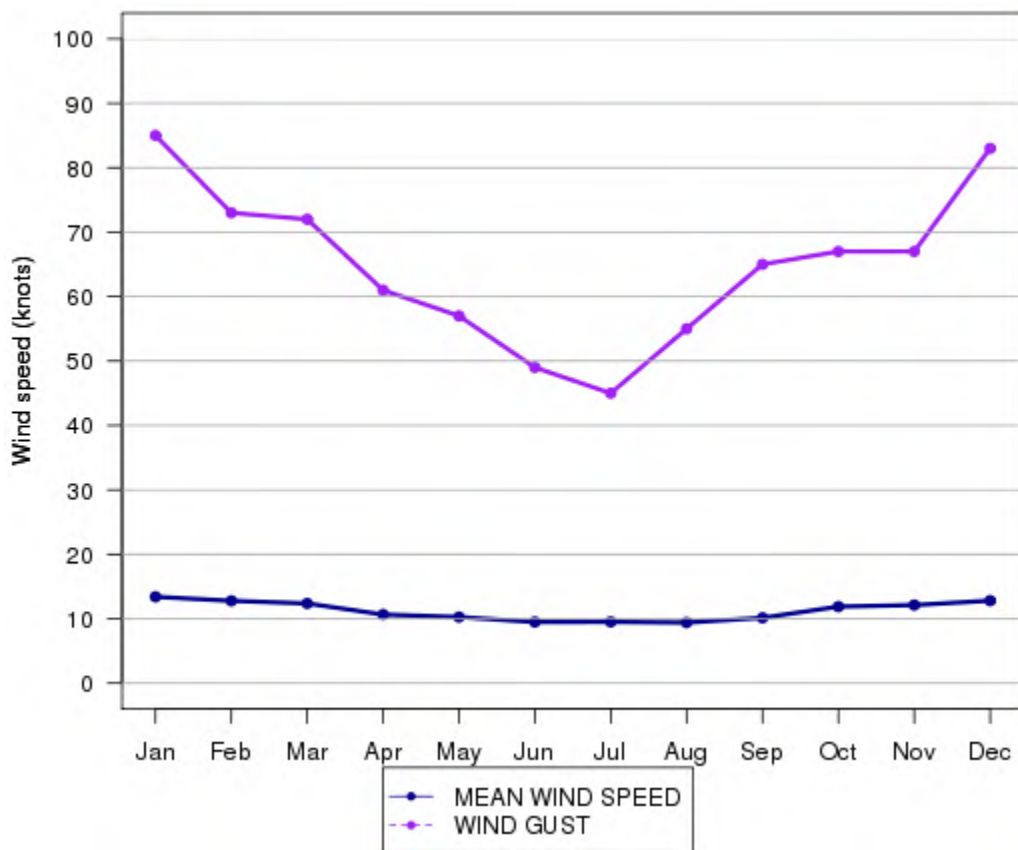
Figure 3.6 Monthly average mean wind speed (1981-2010) and maximum gust i.e. 'instantaneous' speed averaged over 3 seconds (1956-2007) at St Mawgan (near Newquay). Source: Met Office.

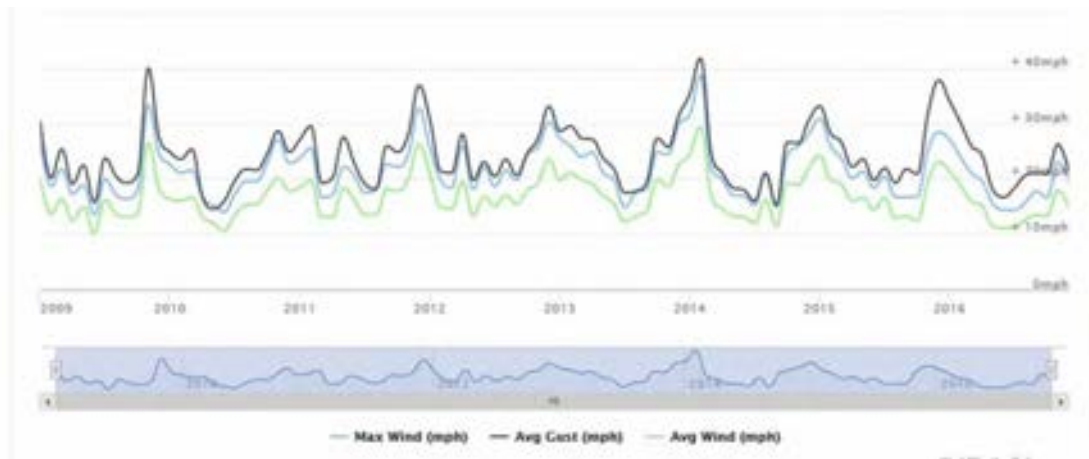
Figure 3.7 Average and maximum wind speeds and gusts (mph) for Penzance (2009-2016). NB 1mph= approx. 0.87knots and 0.45m/s. Source: WorldWeatherOnline.com.

Average wind speed gusts were highest in 2010 and 2014 (40mph and 42mph respectively) which may have contributed to increased windblown sand transportation. Average gusts were also high in 2012, 2013 and 2015 in the early first few months of the year. However, it should be noted that these speeds are recorded at 10m elevation (the dunes are less than 10m crest height) and therefore actual wind speeds across the beach and at the base of the dunes are likely to be significantly lower. Arens (1994 in Van Rijn, 1998) states that when the onshore wind speed is less than 10m/s sand is likely to be only transported as far as the base of the dunes; when wind speeds are greater than 10m/s sands are able to enter the vegetation zone. Overall the wind speeds measured at Penzance (and as a proxy for Marazion) have potential to transport sand across the beach for building at the base of the dune and occasionally gusts could cause sand transport to reach further into the dunes and even overtopping them (as shown from the sand accumulating on the road behind the dune). In terms of future changes, increased frequency and severity of Atlantic depressions could increase wind speeds and potentially windblown transport.

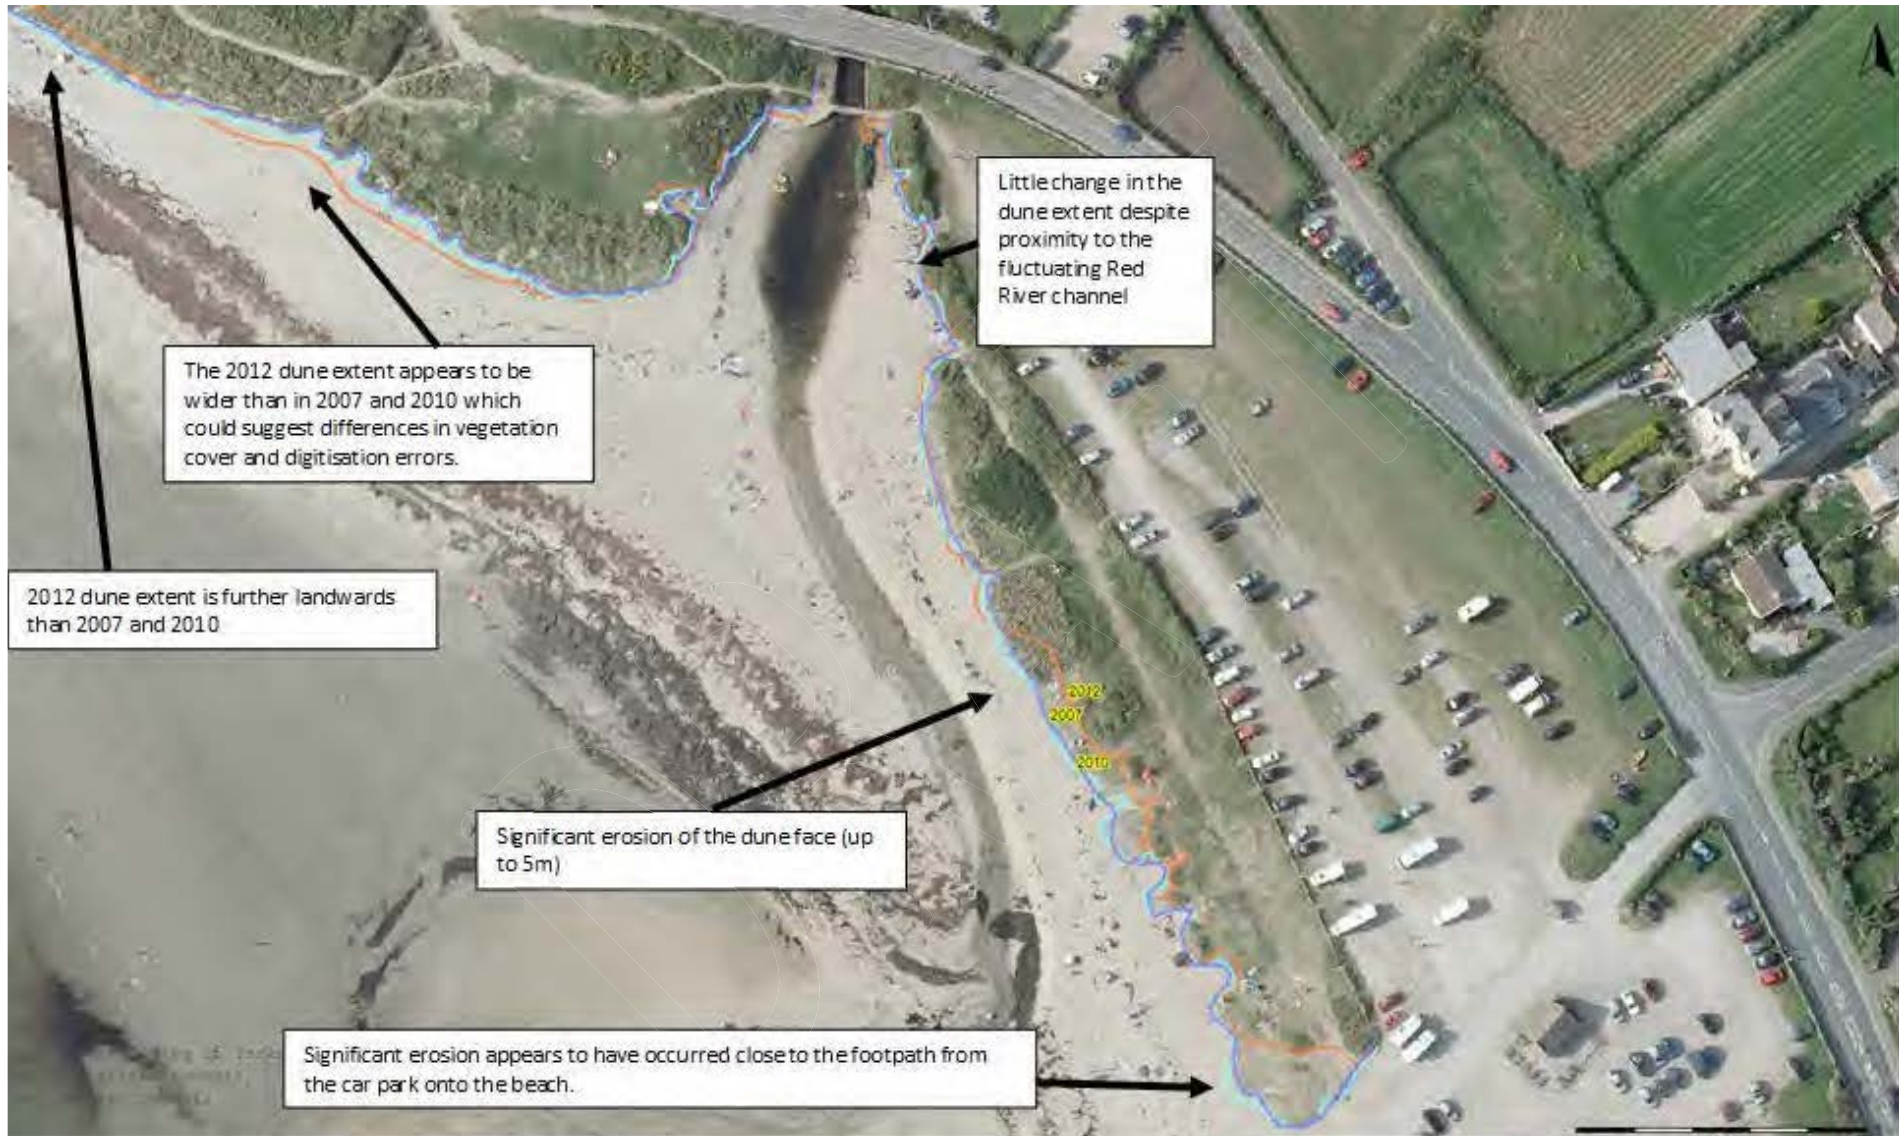
Figure 3.8 Dune toe position at Marazion in 2007, 2010 and 2012 (refer to Appendix C).

- Increased wave action is unlikely to have been the cause of erosion in this area. The eastern part of the frontage gains slightly more shelter from the nearshore rocky outcrops but has experienced erosion. If wave action was the main cause observed retreat would be mirrored on the western side of the Red River, where the sheltering effect is less. This is not the case however and results show some accretion. This is also the case for wind impacts – if increases in wind activity (e.g. during winter of 2010) were a fundamental impact on dune dynamics then they would be expected to be consistent across the area (i.e. both east and west of the Red River); this is not the case and further supports the influence of localised pressures.

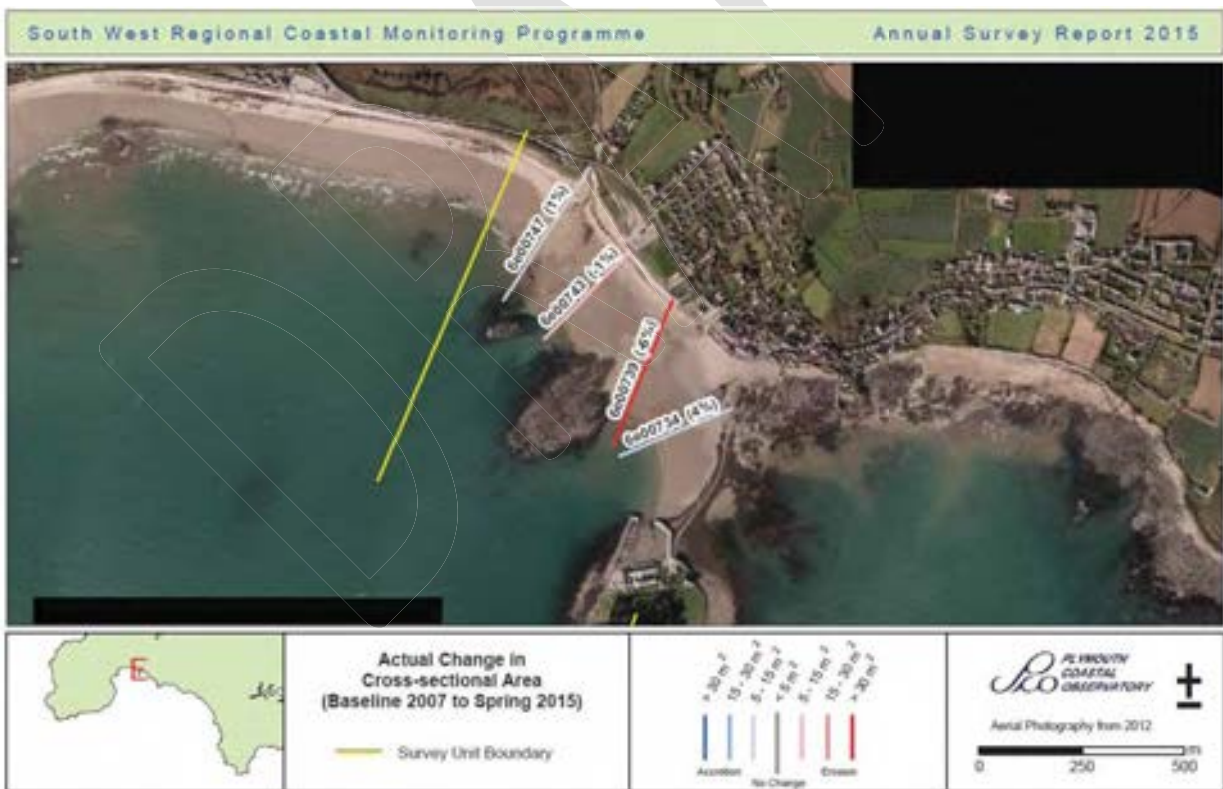
Figure 3.11 Beach profile change at Marazion 2007 to 2015 (source: PCO, 2015).

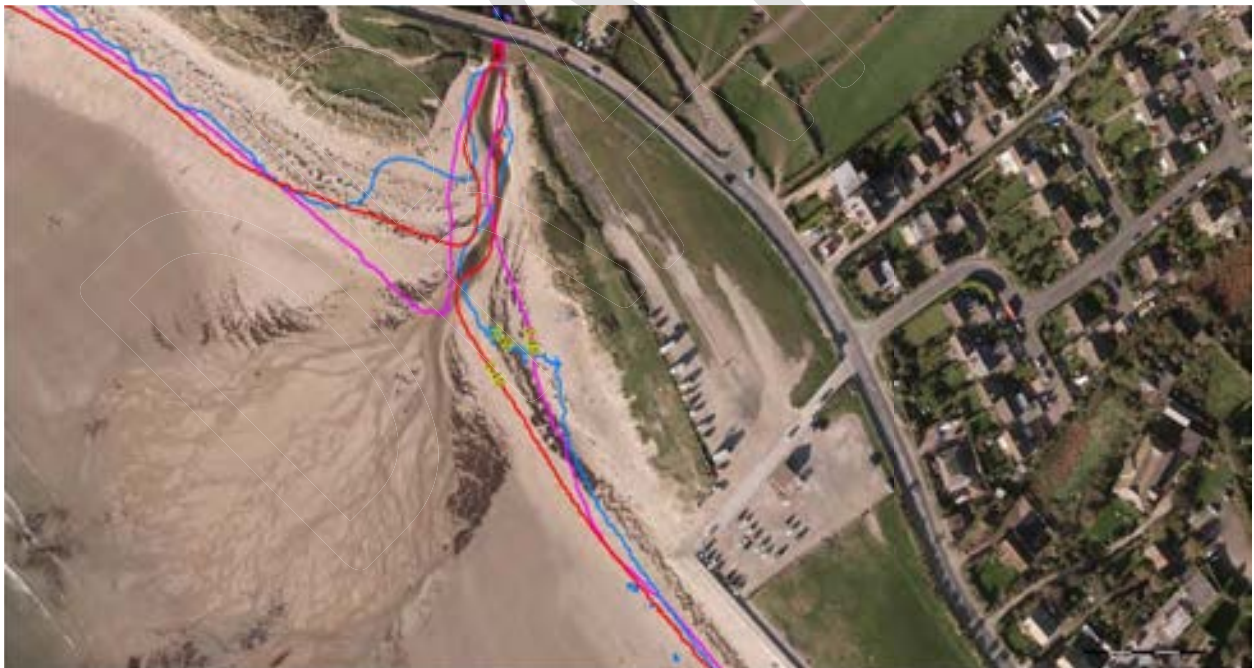
Figure 3.15 MHWs contour change at Marazion beach. Red is 2014, Blue is 2011 and Purple is 2007. Background is 2012 aerial photograph for comparison.

Changes in the Mean High Water Springs (MHWS) contour (refer to Figure 3.15) shows variation on the position of the contour. The MHWS level is heavily influenced by the presence of the Red River channel which meanders and fluctuates its position from west to east across the beach. However, generally to the east of the Red River channel, the MHWS has migrated seawards from 2007 to 2014, supporting the results that the beach has been accreting. To the far west of the Red River channel in front of the dunes the MHWS level has not significantly changed between 2007 and 2011 but in 2014 the MHWS level does move seawards by up to 5m in places. This can be supported by Figure 3.10 which shows erosion of the dune face and subsequent accretion on the upper beach.

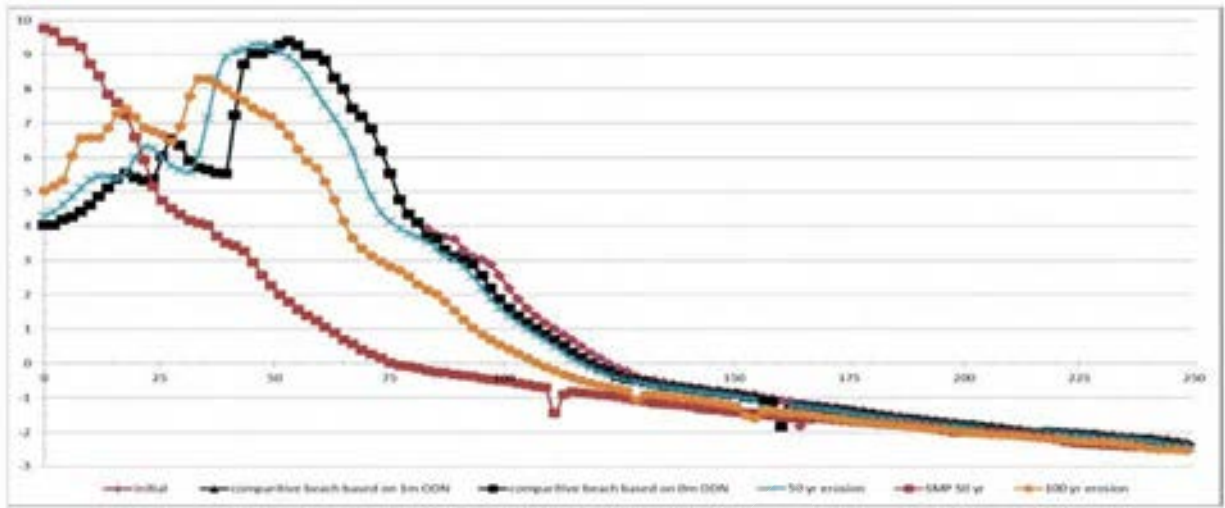
Figure 3.16 Predicted change at Marazion dunes over the next 100 years (Extracted from Royal Haskoning, 2015).

Overall there appears to be various estimates for the future retreat between 15m and 800m over the next 100 years (i.e. 0.15m/year to 8m/year) depending on different scenario assumptions. Whilst the estimates are variable it is likely that with sea level rise erosion will continue; key rocky platforms and outcrops will become more submerged and therefore intercept less wave energy (Royal Haskoning, 2015) and the beach levels will reduce. There will be minimal new sediment in the system to re-feed the beaches (and dunes) and maintain widths. Given the existing width of the dunes is approximately 35m wide, regardless of the estimates, there will be a potential risk of breach of the dunes in the near future, with implications for the road and freshwater habitat behind. However, further more detailed monitoring and assessment will be required to assess potential predictions in more detail. The Strategy recommends establishing a stakeholder group and undertaking a separate adaptation planning exercise within the next 2-5 years.

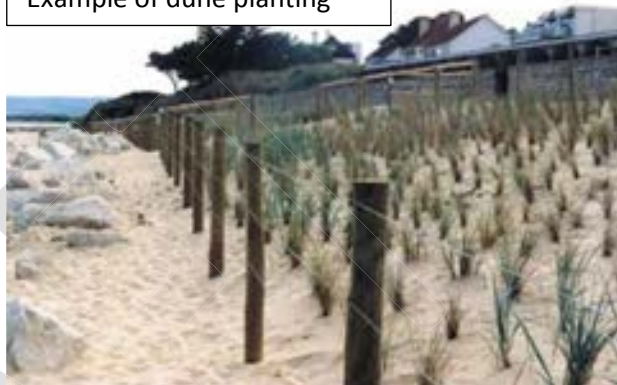
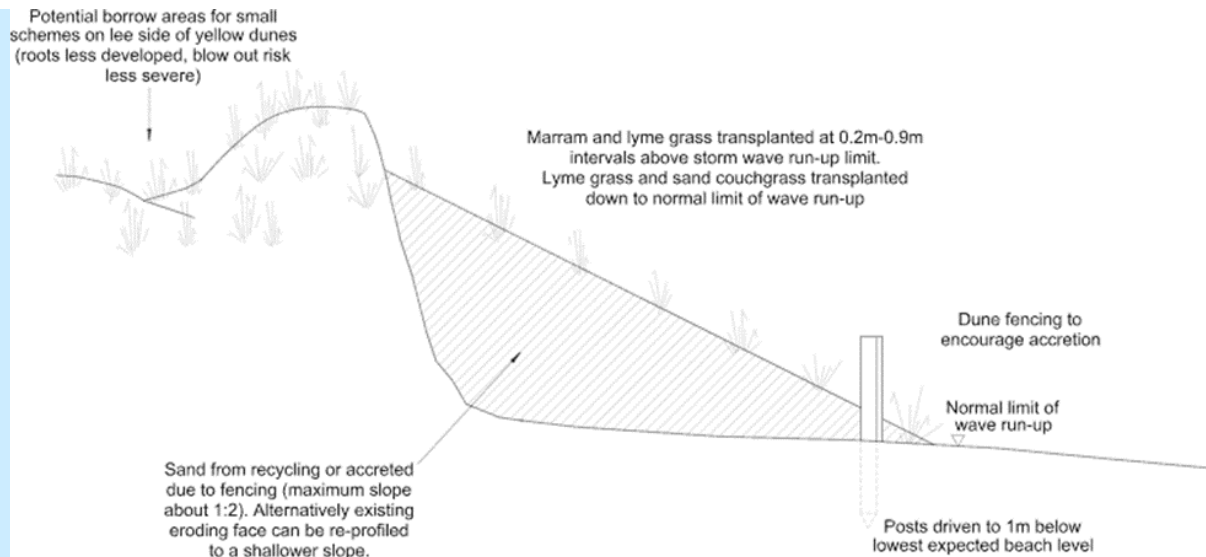
Example of dune planting

- Planting grasses from seed is not recommended in the very active foredune environment.
- Planting should be undertaken in the spring to maximise potential growth and minimise the risk of storm erosion.

- Dune planting schemes must be continuously managed to establish a vigorous growth and to repair natural or human damage.
- Re-profiling, thatching or fencing are normally required in association with planting to enhance dune recovery and to restrict public access or damage.

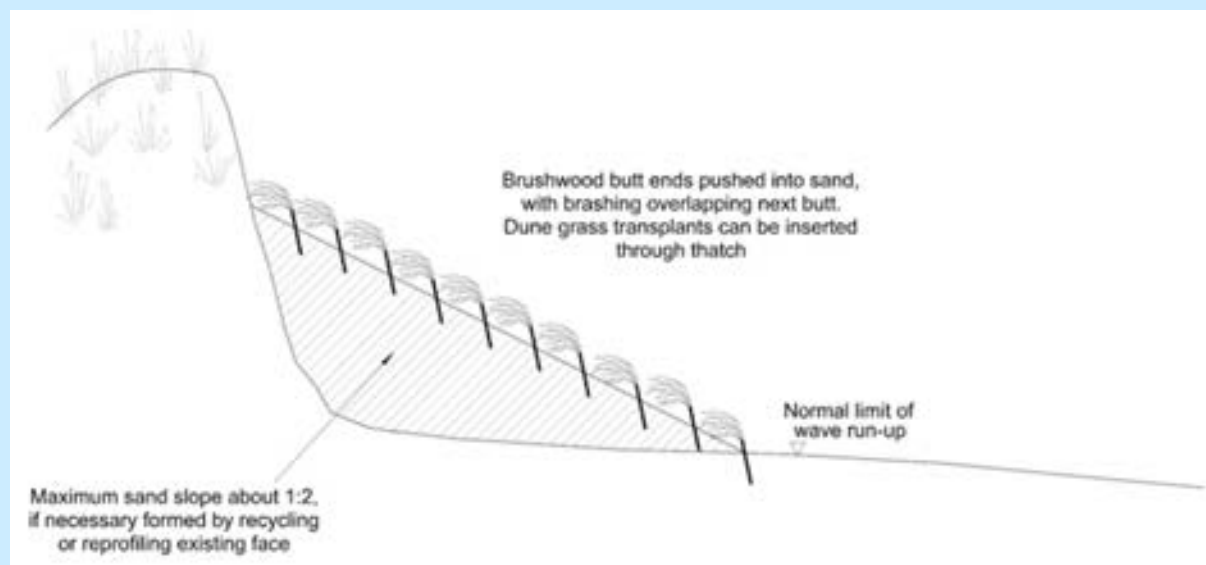
BOX 2: Dune thatching guidance

- Materials can include timber or brushwood cuttings, must be degradable and should not introduce foreign seeds, live cuttings or pollutants that may damage the dune ecology.
- Conifer brushings (lower branches) from spruce or fir are preferred for their flat, fan shapes.
- Thatch should be laid to cover 20% - 30% of the exposed sand surface.
- Dune grasses should be transplanted through the thatch to promote sand retention and restoration of natural habitats.
- Thatching should not be undertaken on steep, freshly eroded slopes. The dune face should be regraded or built out with recycled sand prior to further works. A maximum slope of 1:2 is recommended.
- Thatching should not extend seaward of the line of normal wave run-up.
- Thatch must be regularly maintained to maximise effectiveness and to minimise impact on public use and visual amenity.

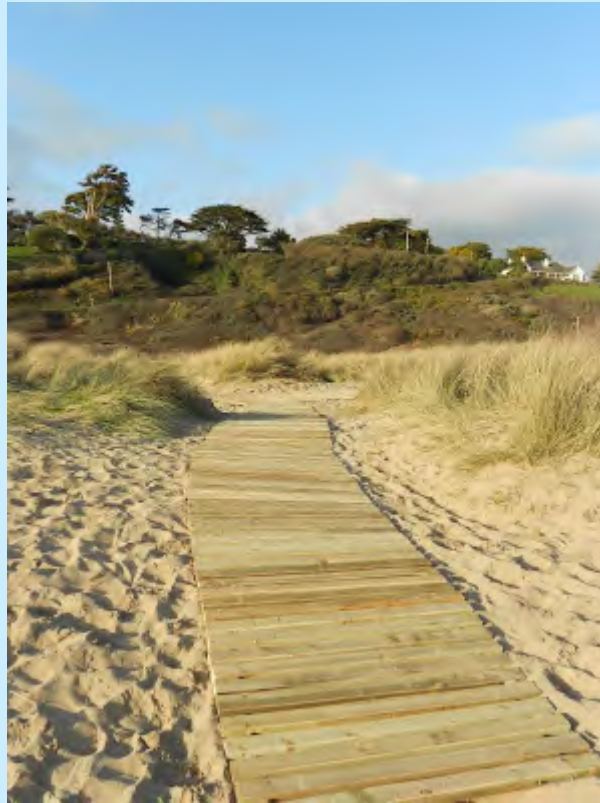
Example of a removable access structure (Source: <http://lizardandpenrose.blogspot.co.uk/2012/03/under-boardwalk.html>; link correct when accessed on 27th September 2017).

- Construction that will remove plant cover and expose areas to erosion during the storm season (winter) is not recommended.
- For removable options non-wood materials such as bark chips or matting are low cost and have low impact on the environment.

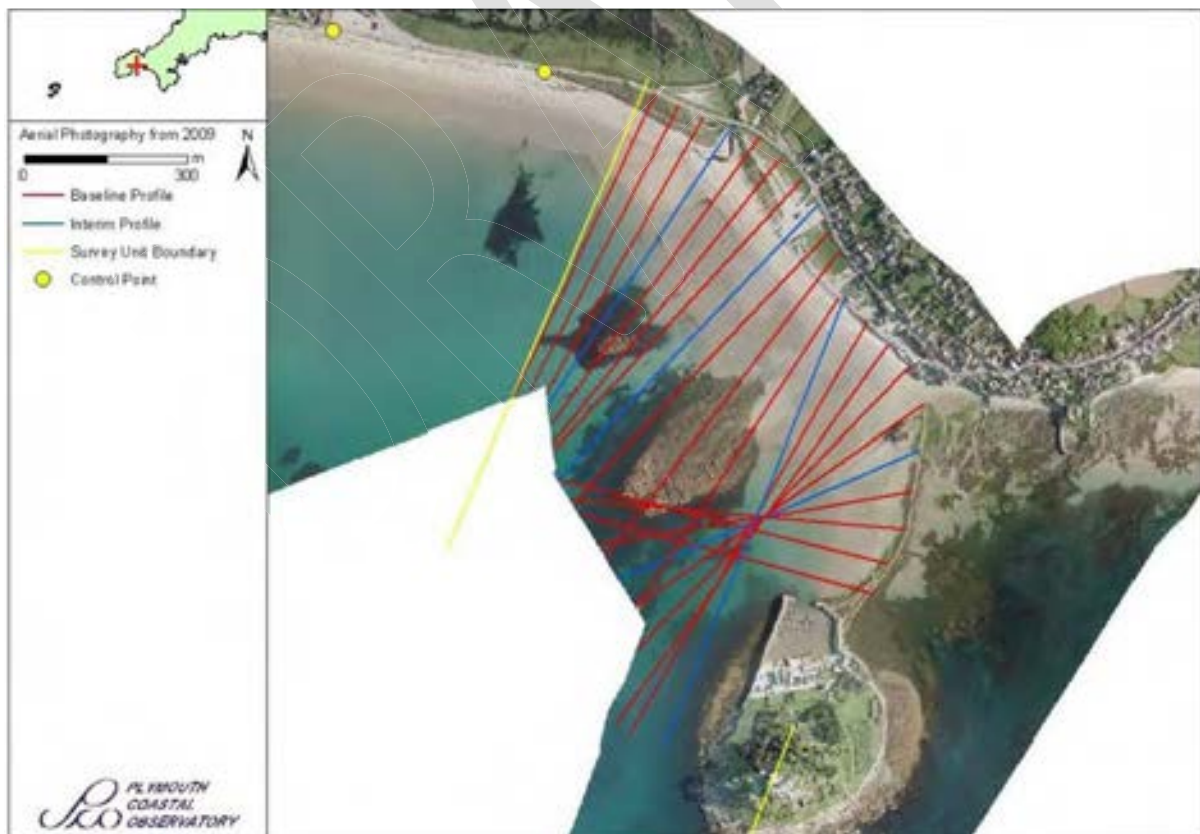
Figure 4.7a Location of beach profiles currently measured by the South West Regional Coastal Monitoring Programme at Marazion within cell 6eSU10-1 – Marazion (Source: Plymouth Coastal Observatory).

Figures 4.7a and 4.7b below show the location of the baseline and interim beach profiles measured at Marazion (refer also to Figure 3.9 to 3.15 above).
